**HABITAT COMPENSATION, RESTORATION
AND CREATION IN THE FRASER RIVER
ESTUARY.**

***Are We Achieving a No-Net Loss of Fish
Habitat ?***

**Canadian Manuscript Report of
Fisheries and Aquatic Sciences No. 2349**

Kistriz, R.U. 1995. Habitat Compensation, Restoration, and Creation in the Fraser River Estuary : Are We Achieving a No-Net-loss of Fish Habitat? Can. Tech. Rept. Fish. Aquat. Sci. 2349. 70 p. plus Appendices (113 p.)

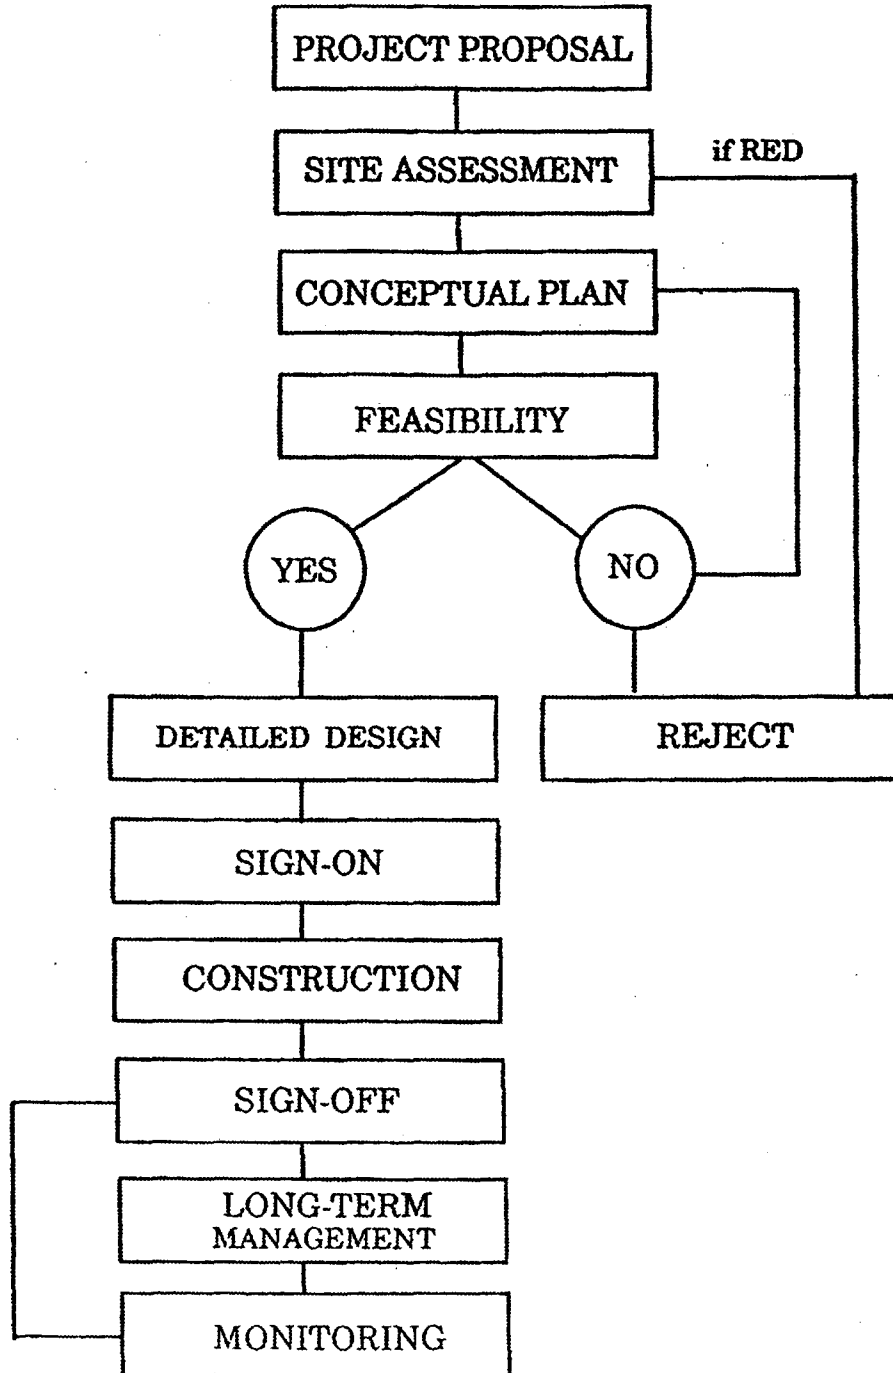
Project Delivery Procedure

The following flow chart illustrates the process described above:

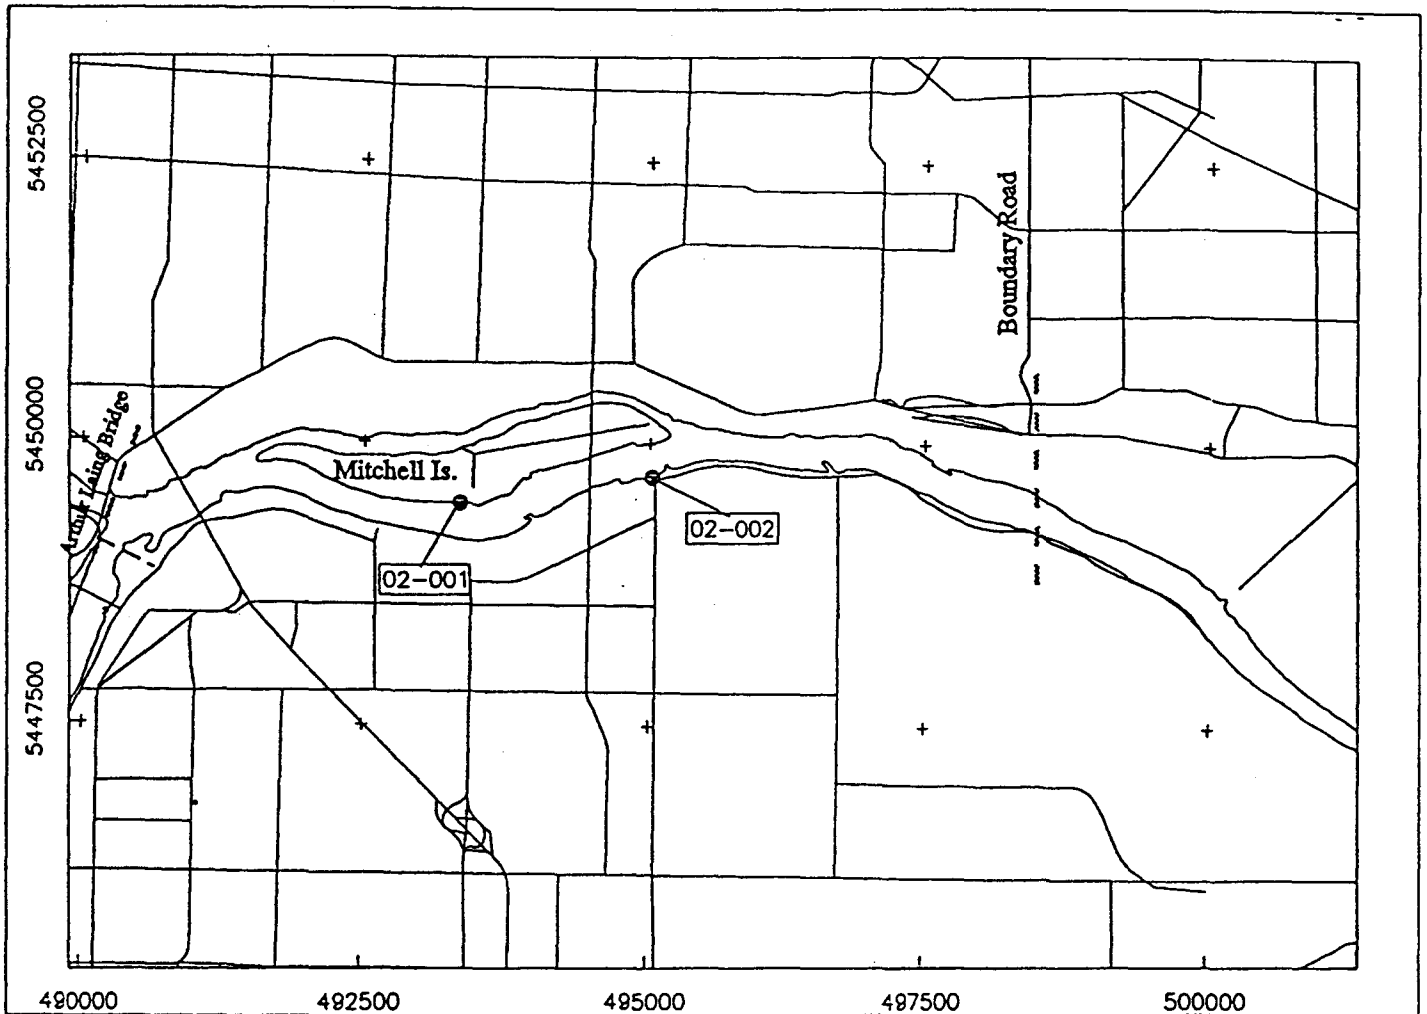
FIGURE 3. HMU 02: NORTH ARM, Boundary Road to Arthur Laing Bridge

Dashed lines represent the HMU boundaries. Dotted lines correspond to the western delta front. Cross-hatched areas are marsh or other wetland types. Black areas are eelgrass beds. Symbols labeled with a boxed number are Habitat Project sites representing compensation (circle), restoration (square) and creation (triangle).

<u>Site No.</u>	<u>Project Name</u>	<u>Category</u>
02-001	Bridgeport Market Compensation Site, Mitchell Is.	Compensation
02-002	Richmond Plywood Compensation Site.	Compensation

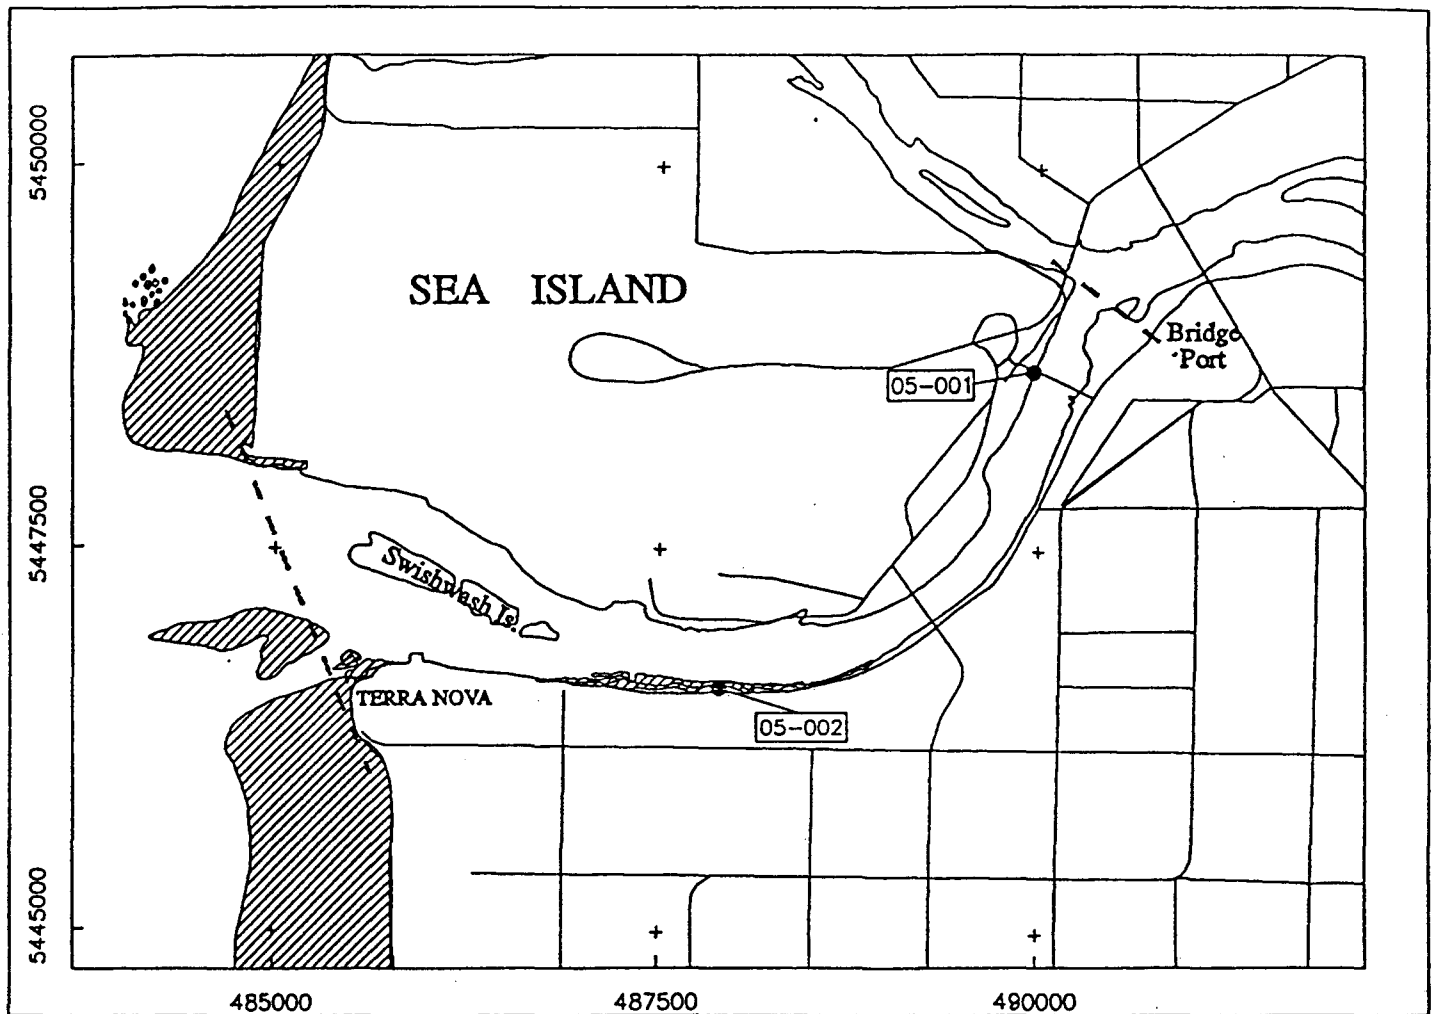
FIGURE 6. HMU 05: MIDDLE ARM, Bridgeport to Swishwash Island

Dashed lines represent the HMU boundaries. Dotted lines correspond to the western delta front. Cross-hatched areas are marsh or other wetland types. Black areas are eelgrass beds. Symbols labeled with a boxed number are Habitat Project sites representing compensation (circle), restoration (square) and creation (triangle).

Site No.	Project Name	Category
05-001	Miller Road Pump Station	Compensation
05-002	No. 2 Road Bridge.	Compensation

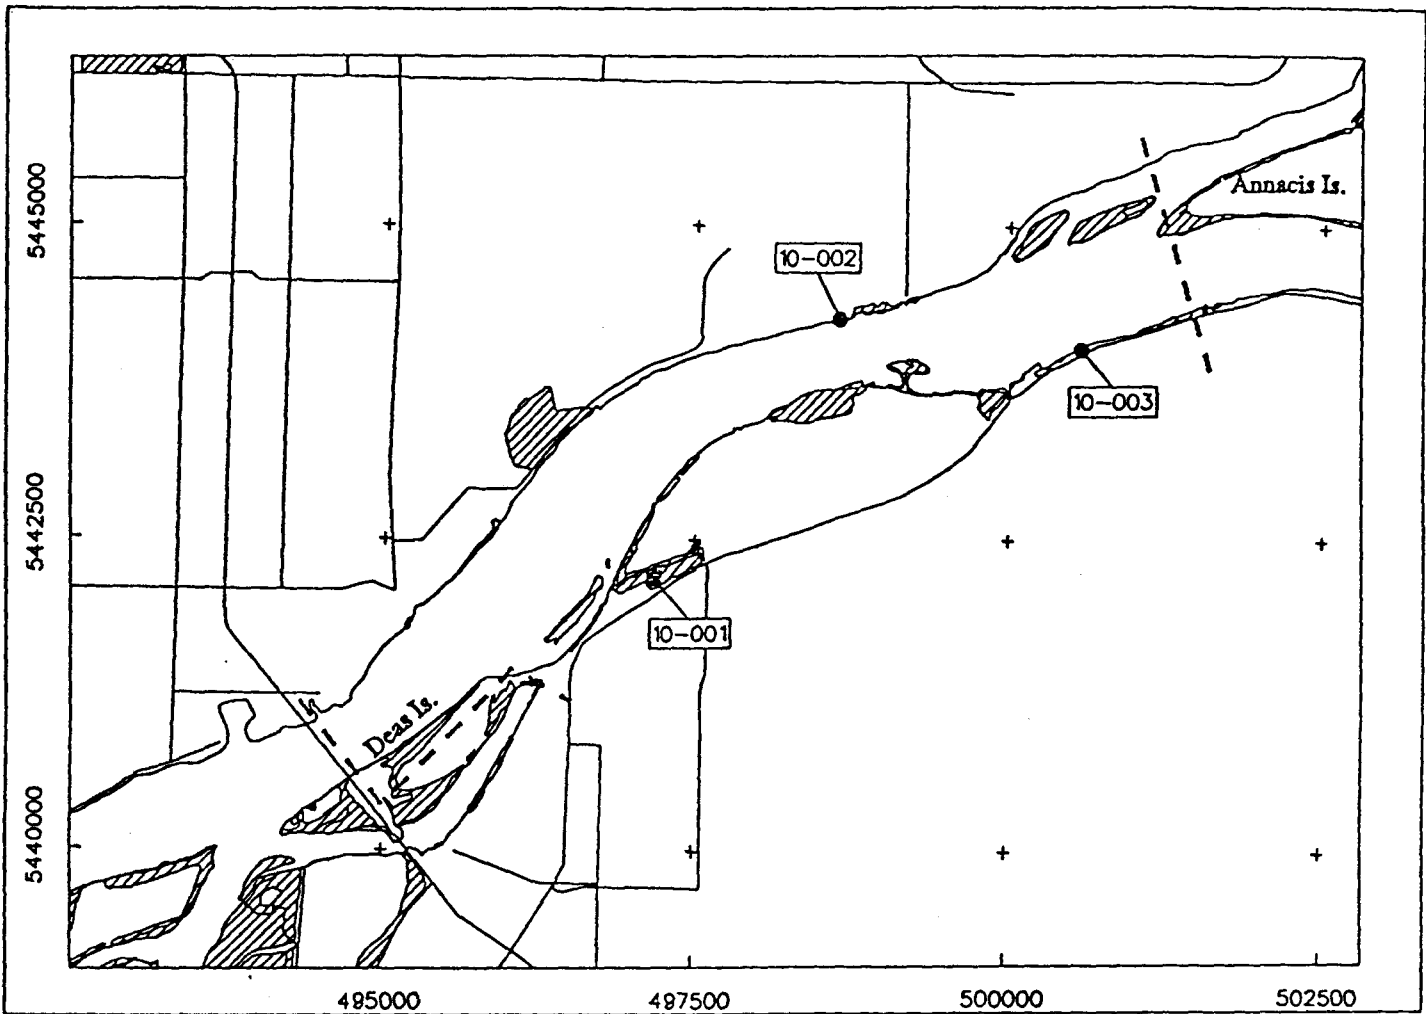
FIGURE 11. HMU 10: SOUTH ARM, Deas Island to Annacis Island

Dashed lines represent the HMU boundaries. Dotted lines correspond to the western delta front. Cross-hatched areas are marsh or other wetland types. Black areas are eelgrass beds. Symbols labeled with a boxed number are Habitat Project sites representing compensation (circle), restoration (square) and creation (triangle).

<u>Site No.</u>	<u>Project Name</u>	<u>Category</u>
10-001	Tilbury Slough Restoration Project	Restoration
10-002	Fraser Richmond Landfill, Compensation Site.	Compensation
10-003	Linwood Homes Ltd., Compensation Site.	Compensation

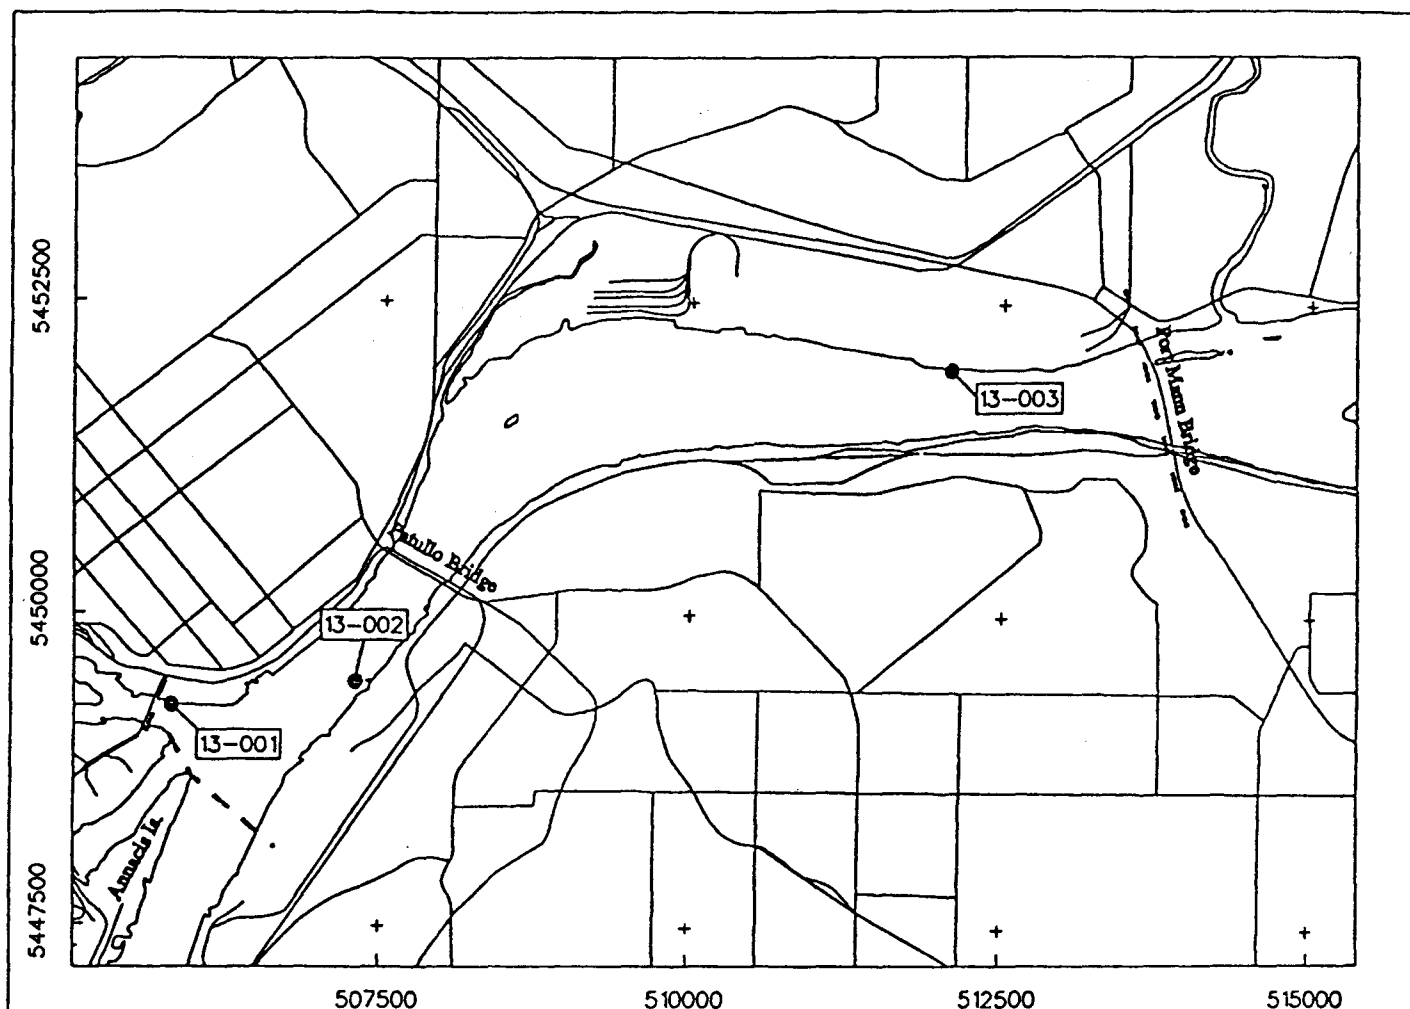
FIGURE 14. HMU 13: SOUTH ARM, Annacis Island to Port Mann Bridge

Dashed lines represent the HMU boundaries. Dotted lines correspond to the western delta front. Cross-hatched areas are marsh or other wetland types. Black areas are eelgrass beds. Symbols labeled with a boxed number are Habitat Project sites representing compensation (circle), restoration (square) and creation (triangle).

<u>Site No.</u>	<u>Project Name</u>	<u>Category</u>
13-001	Westminster Quay, Phase 1, Compensation.	Compensation
13-002	Timberland Basin	Compensation
13-003	Port Mann Log Sort, Compensation Site.	Compensation
